SERVICE BULLETIN No. 72-53

GUILTY

Be on the lookout for a vicious murderer who will ruthlessly destroy breaker arms without let or mercy. His sharp, file-like grooves will rub out the life of the best Bakelite bumper block in as little as 200 miles. The unretouched photograph (Fig. 1) shows up the file-like corners very distinctly.

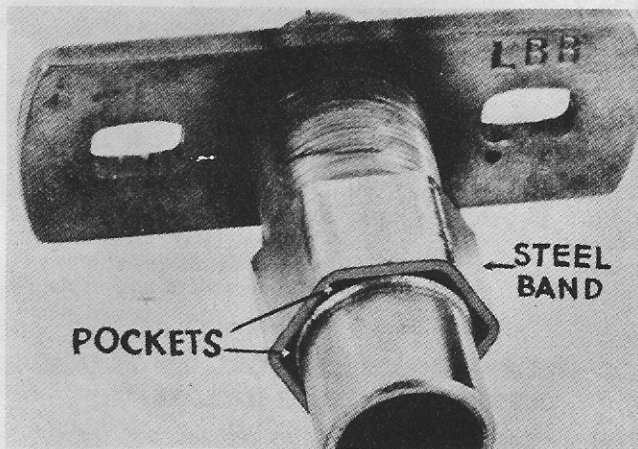
We are talking about the distributor cam that is being furnished by one ignition manufacturer and is being used on many cars in the past couple of years. Up to then the cam was made of solid metal and of comparatively heavy thickness. The new type of cam is a two-piece assembly, consisting of a carrying post and a six or eight sided thin steel band, forced or sweated on to the post. (Fig. 2)

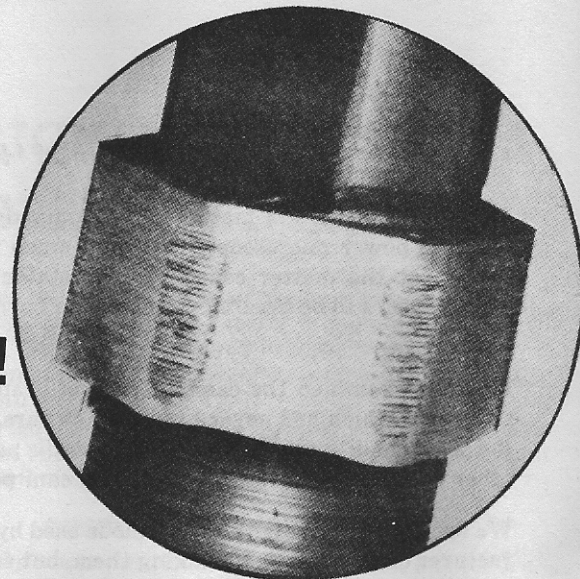
(Fig. 1)

Since the new type of cam appeared, we have been receiving inquiries from the trade regarding abnormal wear of breaker arm Bakelite bumper blocks, when used on cars equipped with the new type cam. We have seen breaker arms of various makes with worn down bumper blocks, where about $\frac{2}{3}$ of the bumper block had been worn off in a comparatively short length of service. Invariably, an examination of such bumper blocks showed deep scoring of the rubbing surface, as if they had been worked over with a rough file; also the breaker arm itself was covered with a film of pulverized Bakelite.

The Rockwell hardness readings on old type solid cams varied from C-55 to C-60, which is quite hard. On new type cams, the hardness readings ran from C-50 to C-52, much softer, as you can see. But on the cam sent in by the customer, the reading was C-43, which is *really* soft.

We might have jumped to the conclusion that it was the softness, and softness only, of the cam that was entirely responsible for the scoring of the cam, had we not been fortunate in receiving seven more worn cams from the same customer. We noticed that in each of these cams, there was present in the pockets formed between the six-sided steel band and the round post to which the band was brazed (Fig. 2), an accumulation of matter, which, to the eye, looked like dirty grease. However, when we

dug out some of this matter and examined it under a hundred power microscope, we found much to our surprise that the matter consisted of metallic chips and what appears to be brazing material and hardened brazing flux.

We are not familiar with the methods used by the manufacturer of these cams in making them, but from a basic viewpoint we can say that no metallic chips or abrasive material should be present on cams or even near cams, as such substances must sooner or later be shaken out of the cam pockets and affect the surface of the cams. It is possible, for instance, for metallic chips to become embedded in the rubbing surface of the Bakelite bumper block, which would, of course, score the cam, causing it in turn to wear down the Bakelite block, much in the

fashion that a scored brake drum and brake lining will mutually wear each other down. We can also surmise that the comparatively softer temper of these cams will aggravate the scoring tendency of the foreign substances and hasten ignition failure.

THE REMEDY? Frankly, we cannot suggest any, as the fault is basic in the manufacture of the cam and should be corrected at the source. We can only offer our recommendation that this type of cam be correctly lubricated by applying a *light* film of high temperature grease to the cam, and it should be checked often.

As soon as you find any signs of roughness or scoring on the cam, the only thing to do is to replace it immediately and without hesitation, with the further precaution of thoroughly cleaning the new cam and washing out as much as possible of the foreign substance out of the pockets. Otherwise you will have to reconcile yourself to extremely short breaker arm service.

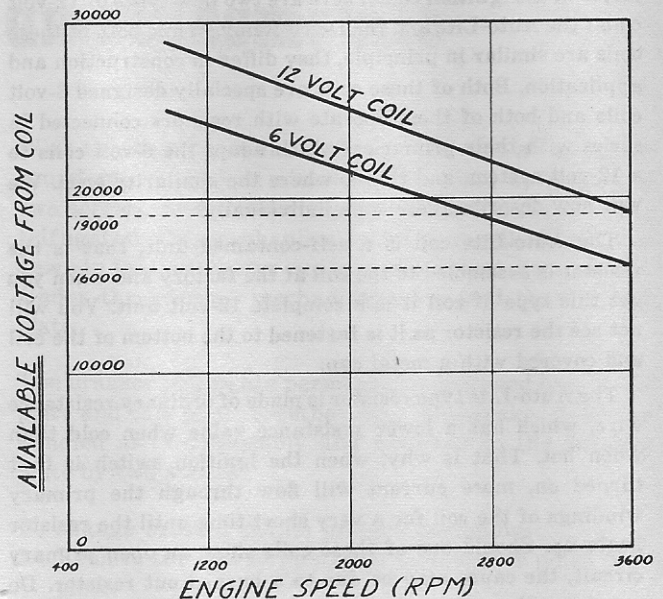
If you consult the graph you will see an actual comparison of the available voltage outputs of 6 and 12-volt coils at the various engine speeds. Thus you will notice, for instance, that the 12-volt coil is capable of producing 19,000 volts at 3600 Engine RPM, while the 6-volt coil can produce only 1600 volts at this high speed. From this graph it is also obvious that the 12-volt system is capable of furnishing greater available spark plug voltages at all engine speeds, and, what is of the utmost importance, at the high engine speeds, where the 6-volt coil frequently fails.

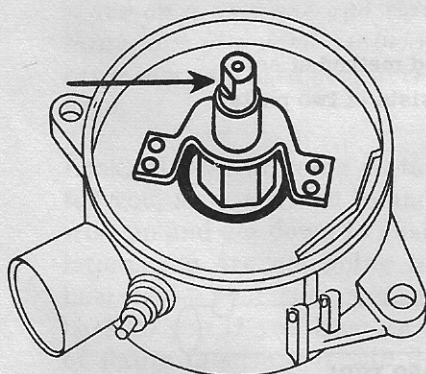
Figure 1; Rotor shaft with flat keyway for rotor.

When Ford first changed to a conventional type distributor in 1948, a considerable amount of trouble was experienced in the field due to the breakage of rotors. Our Blue Streak Service Bulletin #59-49, written in 1949 when the present Ford distributor was comparatively new, attributed the cause of rotor breakage to the snug fit of the rotor on the rotor shaft (Figure 1) and suggested a method for installing the rotor that would minimize the trouble.

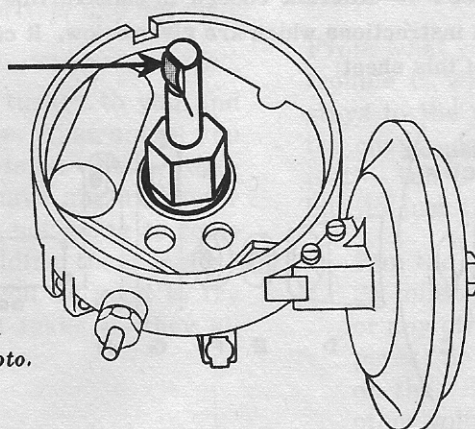
Figure 2; Rotor shaft with flat radiused spring.

Since then, certain changes were made in the Ford distributor itself that helped still further to reduce rotor breakage. The first change consisted of a flat spring with a slightly radiused surface that was inserted into a slot in the distributor rotor shaft alongside the flat section of the shaft. The rotor now fitted over a spring surface which had a certain amount of "give" instead of the previous unyielding solid shaft. (Figure 2)

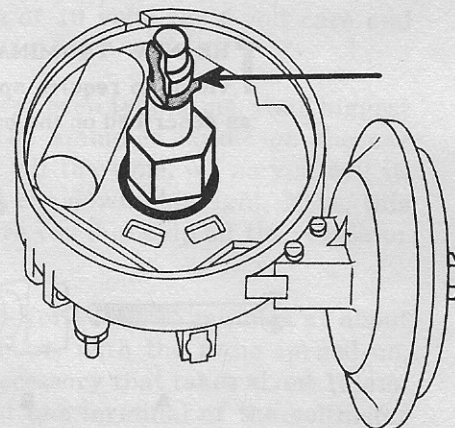
Figure 3; Rotor shaft with spring clip.

This arrangement helped to a certain extent, but not entirely, as the spring insert was comparatively stiff and the rotors still broke. So another change was made in the Ford distributor in the form of a spring clip which slips over the end of the rotor shaft. This clip is much more flexible than the flat spring, but we still hear of occasional rotor breakage, especially in the older models of Ford distributors. (Figure 3)

"The interference can be corrected by removing approximately 0.005" to 0.006" of metal from the end of the blade. This can be done with either emery cloth or a file. (Note: be sure to remove all metal chips and filings after removing material from rotor.) Care must be exercised not to remove more than the specified amount of metal."

Please note that the "distributor terminal housing" or "terminal housing" mentioned in the Ford instructions simply means "distributor heads", and what the instructions mean is that **when you remove the distributor from the car, make sure that the distributor head is on squarely and not cocked over to one side, and then rotate the shaft.** You will be able to feel through the shaft if the rotor segment touches the distributor head firing insert. If it does, you can then make the corrections as recommended in the Ford instructions.
