SERVICE BULLETIN No. 72-53

GUILTY

Be on the lookout for a vicious murderer who will ruthlessly destroy breaker arms without let or mercy. His sharp, file-like grooves will rub out the life of the best Bakelite bumper block in as little as 200 miles. The unretouched photograph (Fig. 1) shows up the file-like corners very distinctly.

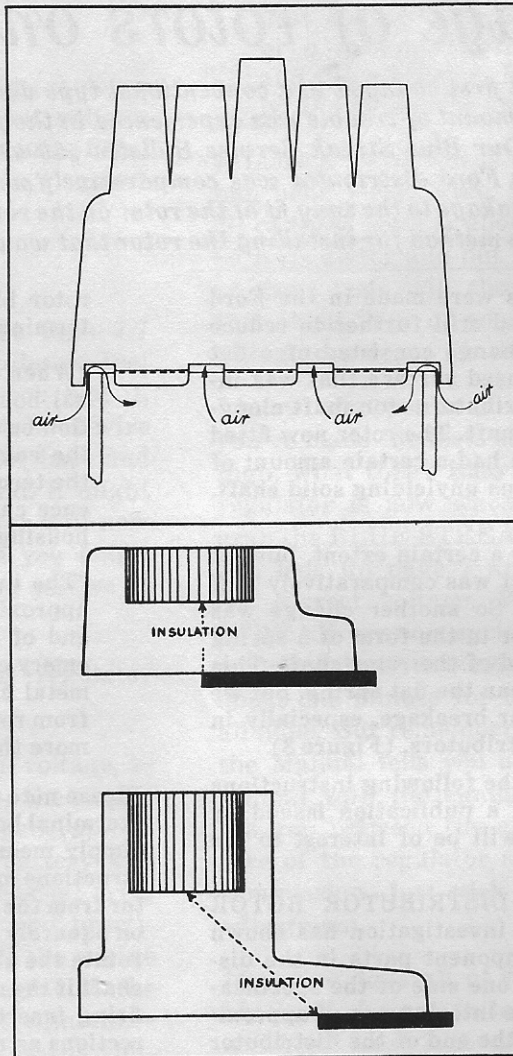
The distributor head has several new features, all intended to prevent high tension leakage. The sides of the head are higher; the high tension towers are deeper; the inside of the head has two ribs molded in between each two adjacent firing inserts. Each one of these features tends to provide a greater insulating distance between the high tension terminals and ground, and in the case of the ribs between the firing inserts, an obstruction against cross-firing between adjacent inserts.

Instead of the conventional ventilating holes in the sides of the distributor head, which often became clogged and deprive the distributor of the necessary ventilation, resulting in moisture condensation and corrosion, the new head has an overhanging rim with many openings for ventilation. These openings cannot become clogged, thus assuring proper ventilation for the distributor.

The new rotor is much higher than the old one and the thickness of the insulation between the grounded distributor shaft and the live high tension rotor parts has been increased from 1/4" to 1/2". This should prevent the occasional cases of the high tension firing right through the rotor to the shaft.

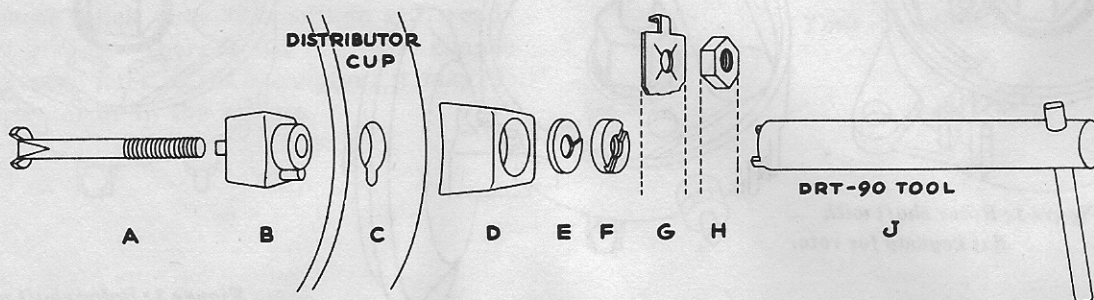
THE NEW TERMINAL POST is different enough in construction and method of servicing to require special instructions which are given below. It consists of two parts as described on the back of this sheet:

1. A molded Bakelite part B, which fits inside the distributor cup C and is shaped with a key, which fits into a key-way in the distributor cup C, preventing this part from turning. It also has another key which engages part A.
2. A long threaded metal stud A, which fits through a hole in part B and is slotted on one end to fit over the key of part B.

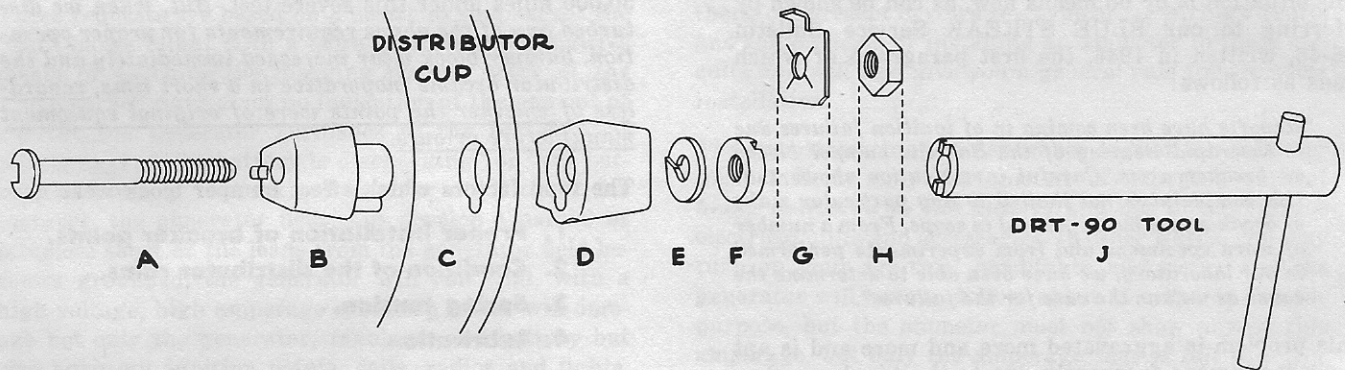
The threaded section of stud A is long enough to take the coil - to - distributor primary wire terminal, a pressure washer G and the conventional hex nut H fastening the primary wire.

3. Another molded Bakelite part D, which fits on the outside of the distributor cup and also has a key-way which engages with that portion of the key of part B, which extends beyond the cup. In this manner the three parts are locked together and none can turn in relation to the other or to the distributor cup.
4. A lockwasher E, which fits into part D.
5. A slotted round nut F, which screws onto stud A and on top of lockwasher E. This nut, when screwed down all the way, keeps the entire assembly tight.

In order to remove the breaker arm from the distributor, the following procedure should be followed:

1. Remove the hex nut H, the flat pressure washer G and the primary wire.
2. Using wrench DRT-90, loosen the round nut F sufficiently to permit you to press in stud A.
3. Pressing in stud A makes it possible to pull out the breaker arm spring and the breaker arm, as well as the condenser terminal.
